HO-1037

George Powers Blacksmith House  
2760 Washington Road (Route 97)  
Private

# Maryland Historical Trust Maryland Inventory of Historic Properties Form

historic George Powers Blacksmith House

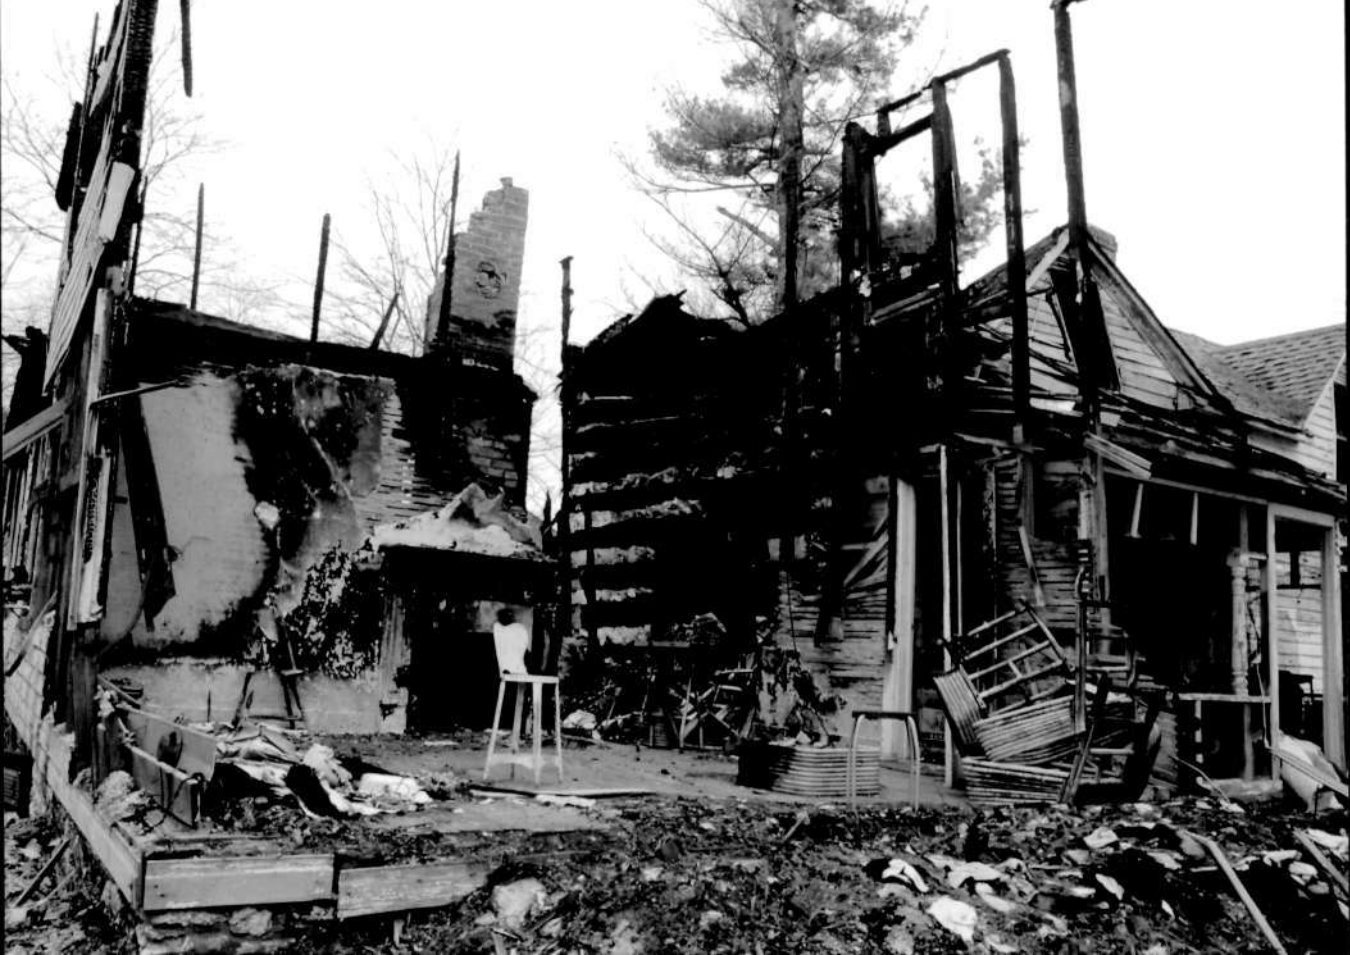
1 of 6

On the southeast elevation the first story has a door in the center of the original three bays, with a window to each side and a three-bay, one-story porch on the front with three turned wood posts, a stone deck, v-groove board soffit, and open eaves. All of the openings are boarded up. The upper story has a central gabled wall dormer that is missing its sash. There is a box cornice.

House, southeast elevation, from south

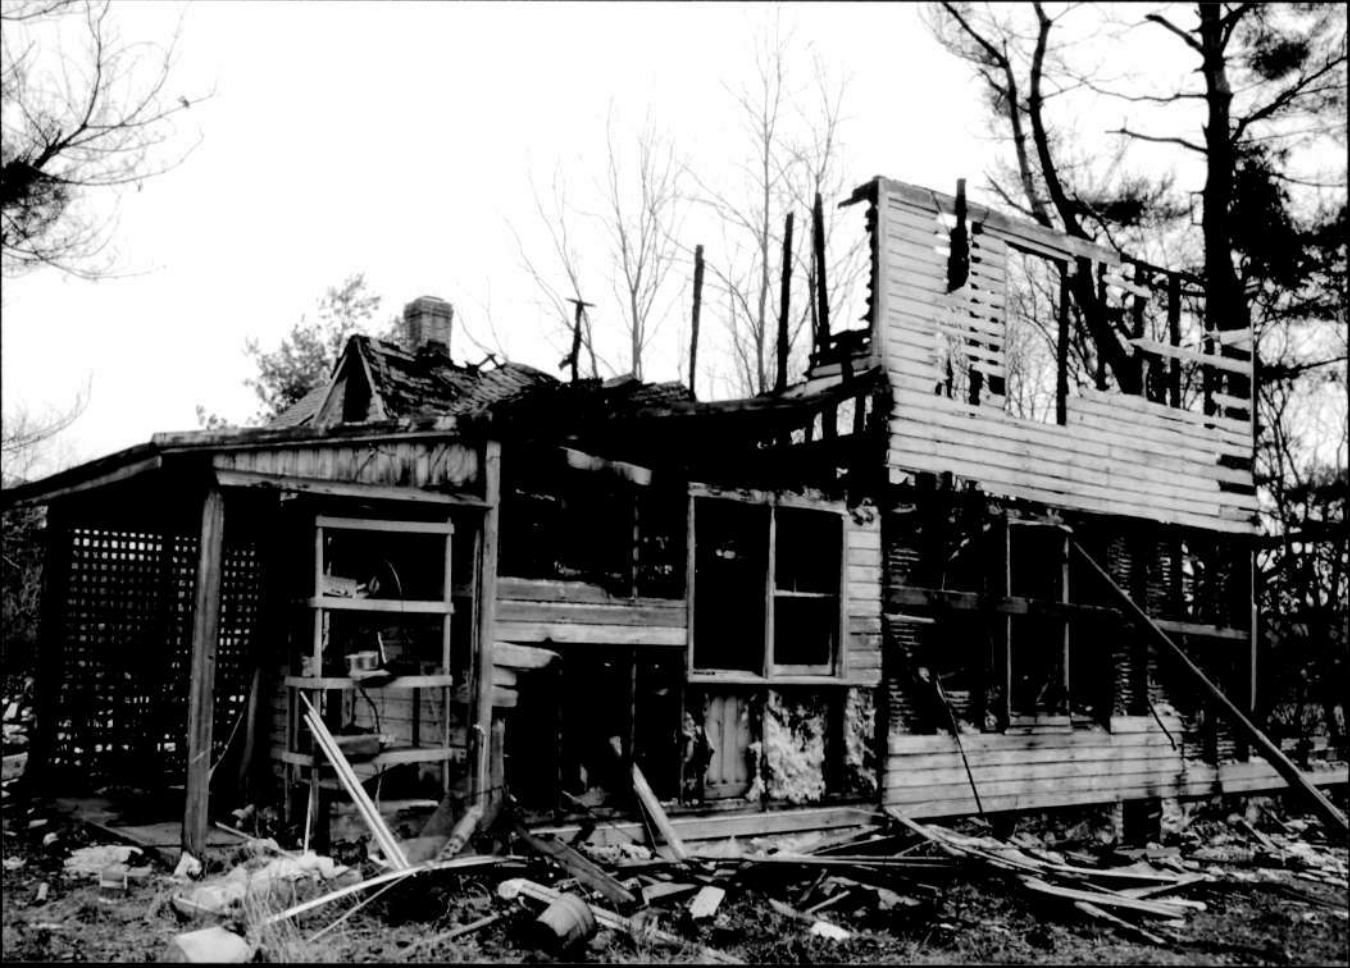
2 of 6

The southwest elevation of the main block has a window opening in the center of the first story with 1-inch-thick board jambs pegged to the log ends. A doorway was cut through this wall to the south of the window opening to get access to the southwest addition, and the boards around this doorway are fastened with cut nails.

The southwest addition was a two-story structure with two rooms, one to the southeast and one to the northwest. It has a rubble stone foundation, and was built of sash-sawn 2 by 4 studs with circular-sawn lath on the interior and German siding fastened with cut nails on the exterior. No portion of the roof survives. The southeast room on the first story has random-width pine flooring that runs northwest-southeast and is 3 to 5 inches wide. There is a fireplace centered on the northwest wall, with splayed brick jambs and a parged surround. It has a wood mantel with applied plaques on the pilasters and frieze. The addition projects beyond the front porch of the main block. The northwest room has plaster on brick on the back side of the southeast room fireplace. To the southwest of this is a built-in cupboard that is now all burned. Part of the west corner post survives and is 4 inches square.

House, southwest elevation, from west

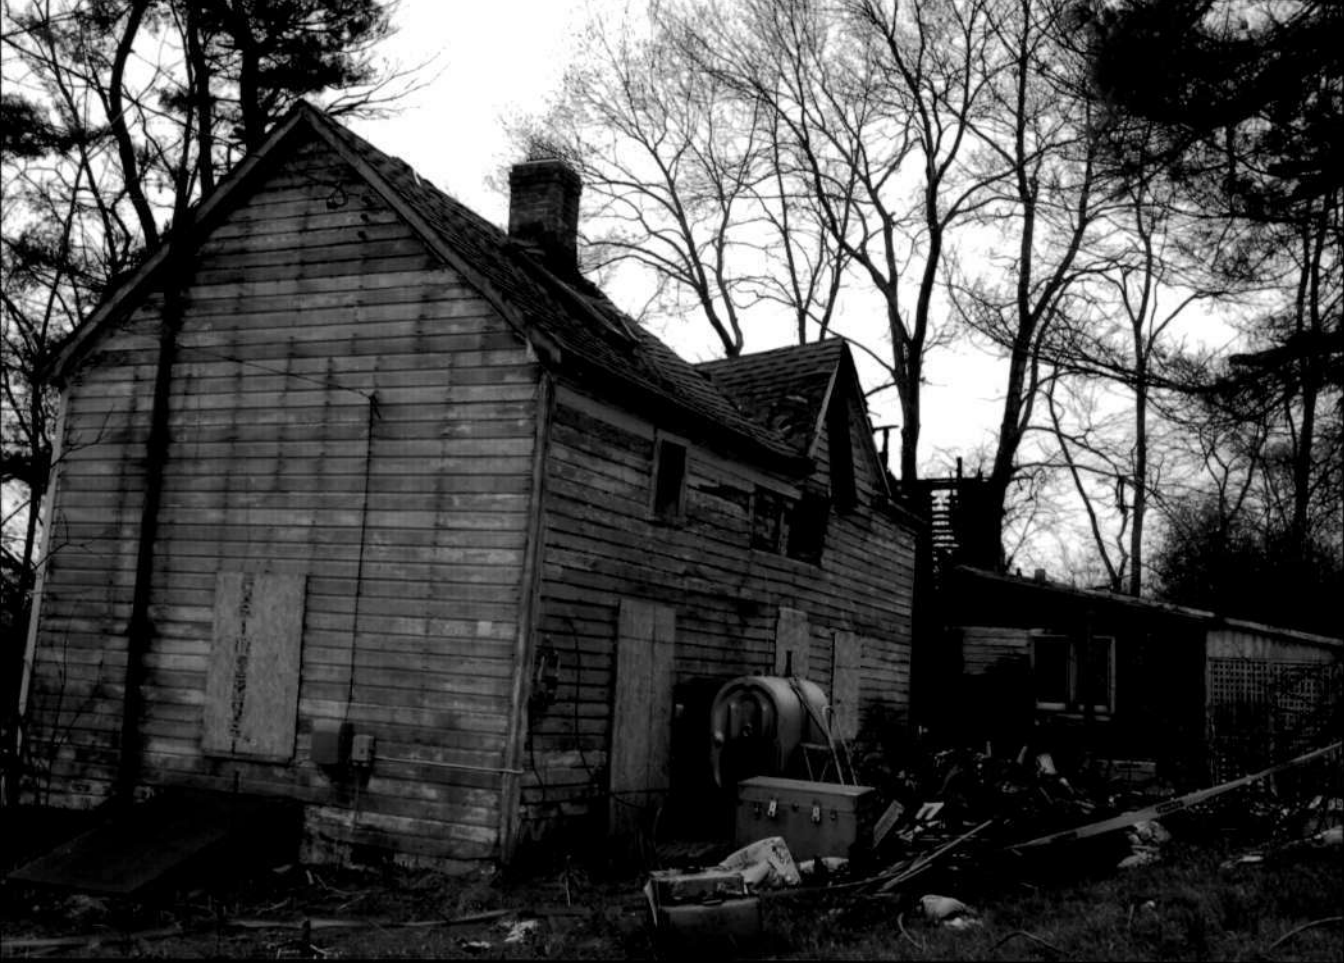
The northeast elevation has a steel cellar bulkhead door on a stone foundation. The first story has a boarded-up window opening and the gable end has no opening. The northwest elevation, on the first story, has a boarded-up doorway in the north bay, a boarded-up window opening in the center, and a boarded-up window opening in the west bay that was a doorway earlier and has been in-filled at the bottom with German siding. In the upper story the north bay has a small window opening, beneath the eave, that has head-cut trim. The center bay has had siding removed, which exposes a corner post to the north and v-notches to the west, with a window opening to the west of it. The west bay has a gabled wall dormer with a large window opening. The north bay of the roof has a skylight. At the west corner the parging is gone, revealing a rotted log at ground level. The exterior faces of the logs on both sections of this elevation are whitewashed.

House, northeast + northwest elevations  
3 of 6

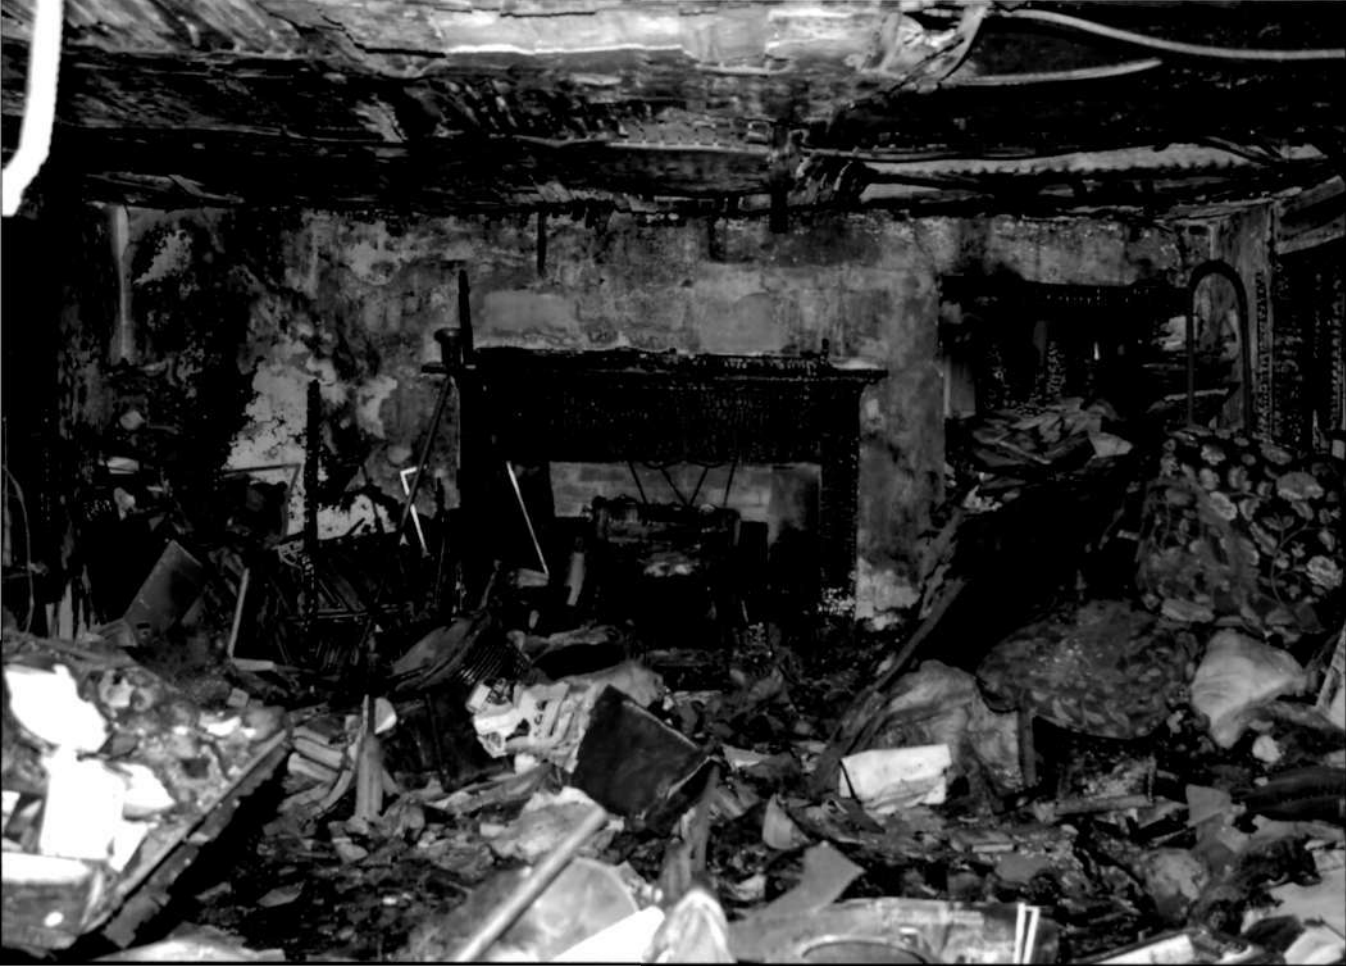
H of 6

The first story of the main block has a parged fireplace at the northeast end of the original southwestern section, with a simple, charred wood mantel. A doorway to the east of the fireplace is blocked by debris. There is an enclosed winder stair that partially survives in the west corner, with beaded vertical boards. There is sawn vertical lath with plaster on the walls, and plaster on lath on the ceiling. The half walls of the upper story are of logs. The northeast addition has a new bathroom in the east corner of the first story.

House, southwest room in log section, v.w.  
northeast

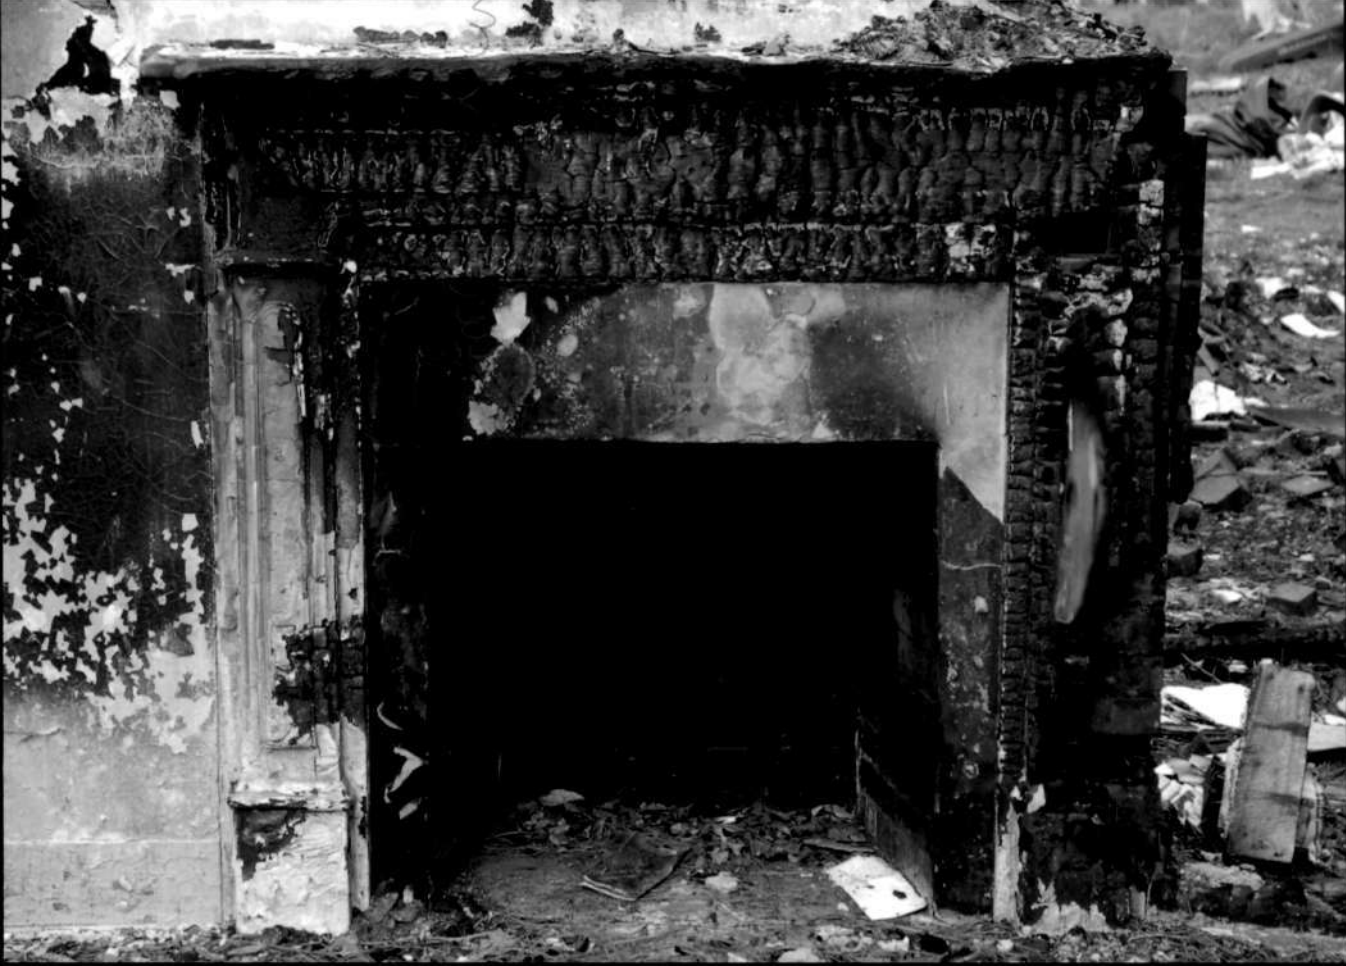
5 of 6

House, south room in frame section, mantel

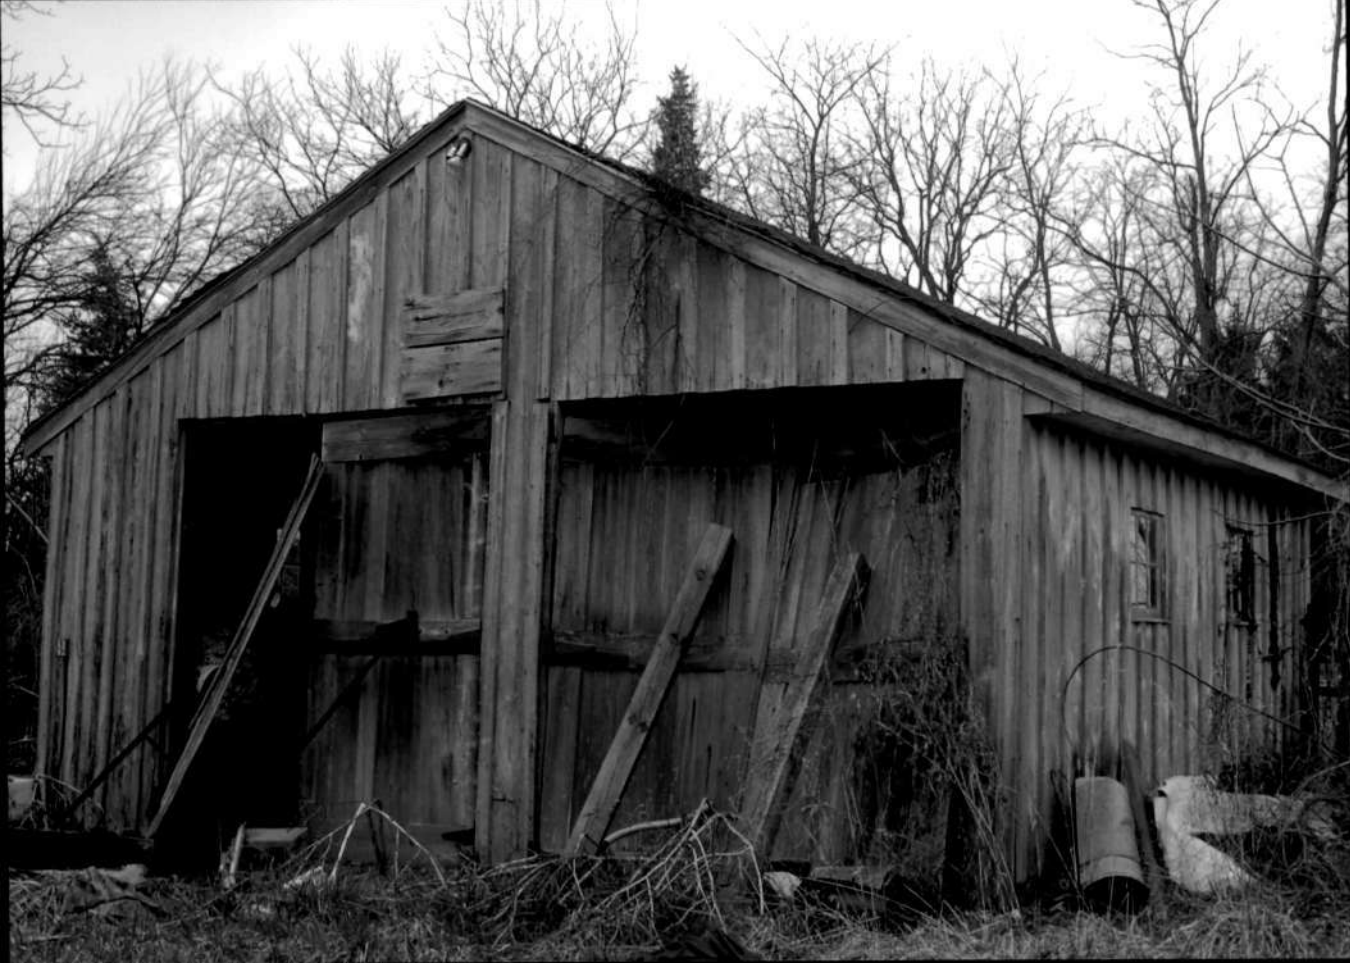
6 of 6

There is a garage about 75 feet northwest of the house. It is a one-story, two-bay by two-bay frame structure with a concrete foundation, board and batten siding, and a gable roof with asphalt shingles and a northwest-southeast ridge. There are holes in the roof. The southeast elevation has two pair of large doors of beaded-edge-and-center vertical boards, and they are hung on T hinges. The southwest and northeast elevations each have two six-light sash. The northwest elevation has a Dutch door to the north, of beaded-edge-and-center vertical boards, and a six-light sash to the west. The garage is built of circular-sawn 2 by 4s.

garage, southeast + northeast elevations
